INTRODUCTION:

Inspection Details

Home Type: Single Family Home

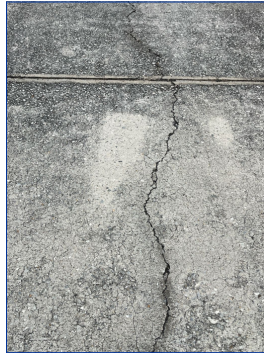
Driveway

- **Issue:** Minor settlement cracks were noted to the poured concrete driveway in several locations. This may allow water to intrude and erode the soil more creating a greater settlement.

Recommendation: Sealing (caulking) the gaps to prevent water intrusion and further cracking.

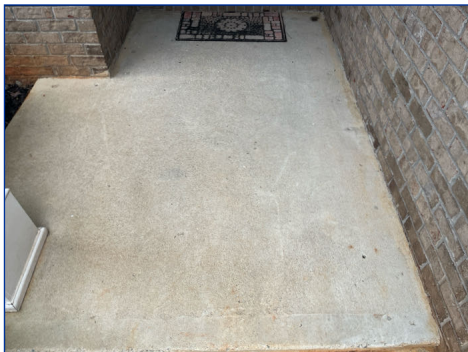
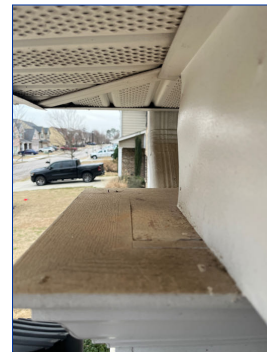
Porch

- **Issue:** The top of the columns have bare wood. This may allow water or pest intrusion to the wood.

Recommendation: Have ALL areas of exposed wood seal/ painted by a qualified contractor.

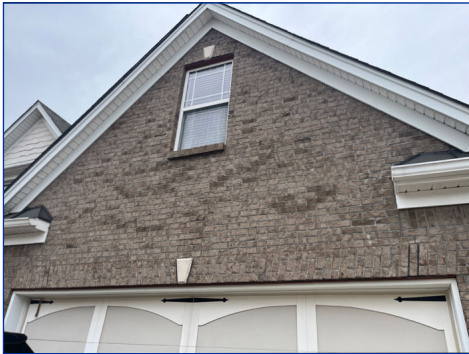
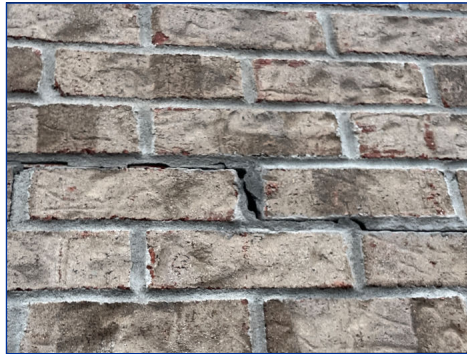
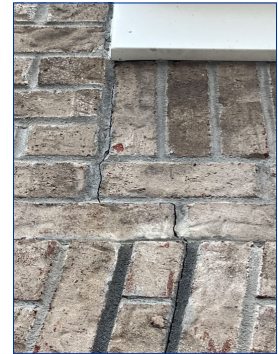
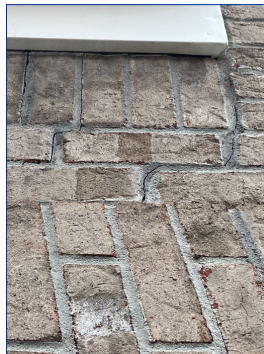
Exterior Surface Veener

- Issue: Visible crack (s) were found in the brick veneer over the garage door area. This is usually caused by the deflection in the steel lintel beam across the garage header.

Recommendation: Further evaluation by qualified masonry contractor to determine the needed repairs. Additional bolts are needed to support the brick.

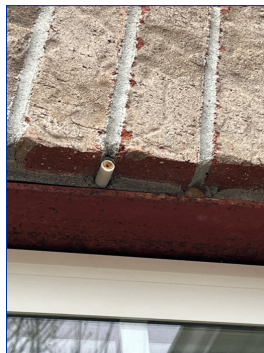
Weep Holes / Flashing

- Issue: The weep holes are clogged with dirt. This may prevent them from expelling moisture as designed.

Recommendation: Have the weep holes cleared open by a qualified contractor.

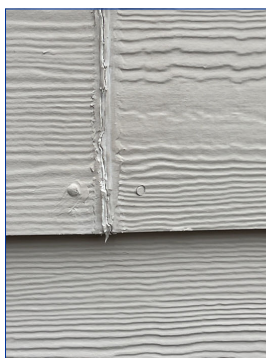
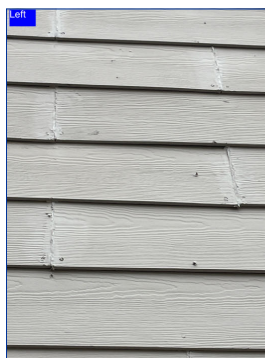
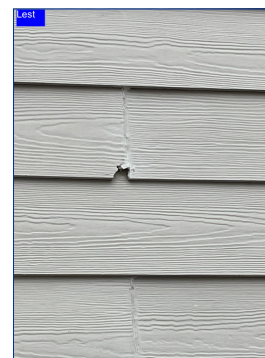
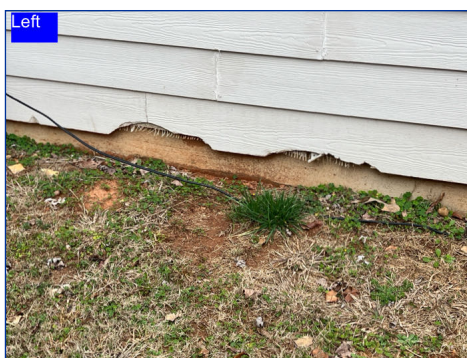
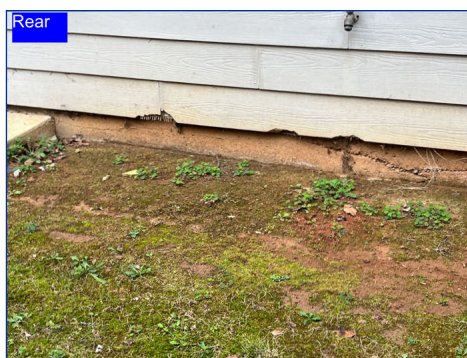
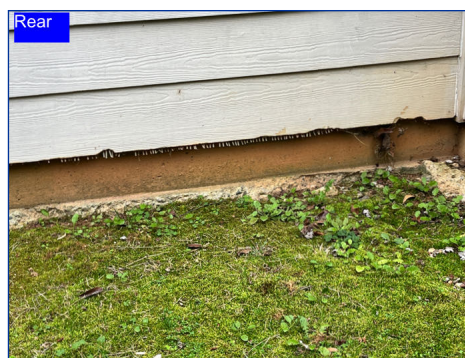
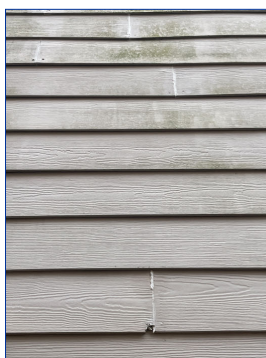
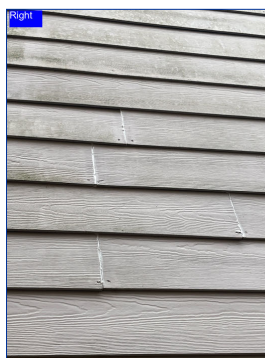
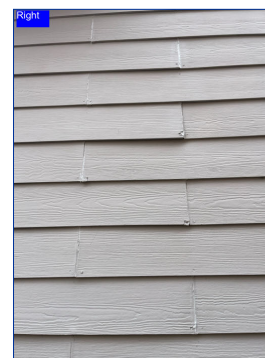
Exterior Surface

- 1) There are multiple overdriven and or exposed nail heads throughout the exterior siding. These areas will allow moisture intrusion into the boards causing further damage.
- 2) Several of the bottom boards were damaged. This may allow water intrusion the sheathing behind the siding.
- 3) Several of the caulk joints are cracked. This may allow water intrusion behind the siding.

- 1) Have these nails sealed per the manufacturer's specifications to prevent early decay.
- 2) Have all damaged siding repaired or replaced by a qualified contractor.
- 3) Have the damaged caulk repaired by a qualified contractor.

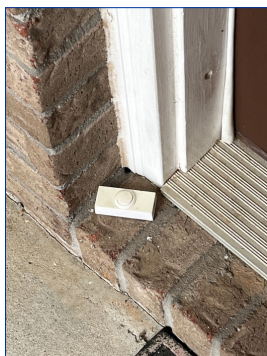
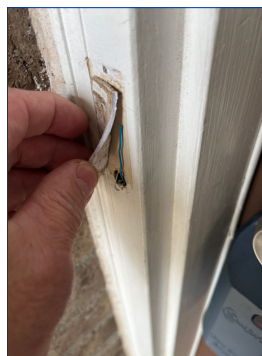
Door Bell

Issue: The doorbell was resting on the front porch at the time of the inspection. Also the wiring for the door bell was not connected.

Recommendation: Have a functional doorbell installed by a qualified contractor.

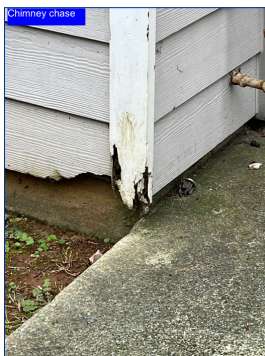
Trim

Issue: Damage was found to the exterior wood trim near the back patio. This is most likely caused by the gutter above cascading water to the cement patio which splashes against the wood trim.

Recommendation: Have the damaged areas of wood repaired or replaced by a qualified contractor. Have the downspout redirected away from the patio.

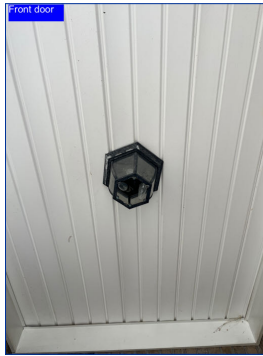
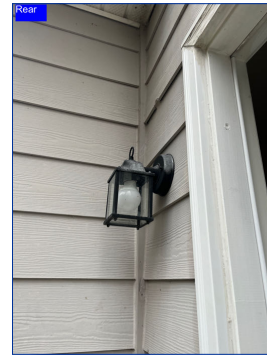
Exterior Lighting

Issue: The exterior lights were not working at the time of the inspection which is a switch or bulb issue.

Recommendation: Replace light bulbs. If the lights still don't work, have them further evaluated by a licensed electrician.

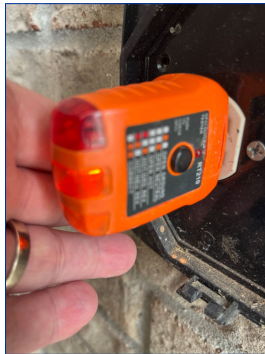
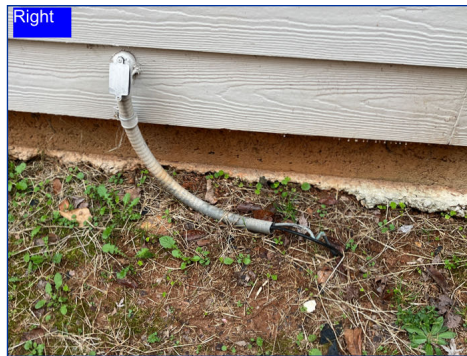
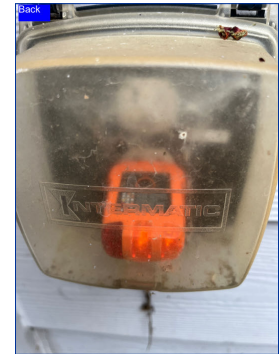
Exterior Outlet

Issue: Exposed wires were noted along the right side of the home. This creates a safety hazard as the wires could become energized.

Recommendation: Have the wires removed and the box properly capped off by a qualified electrician.

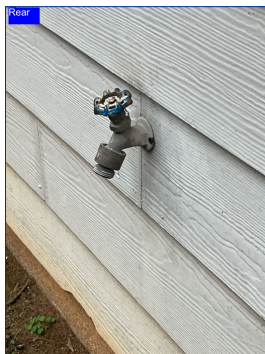
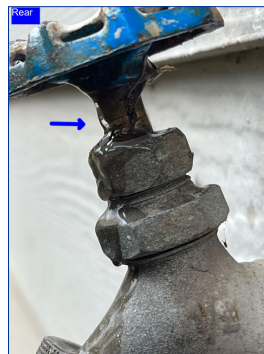
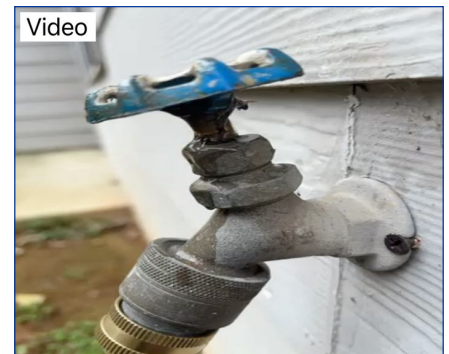
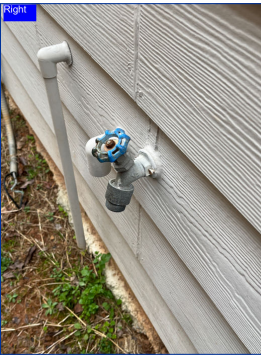
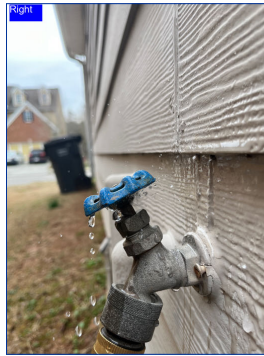
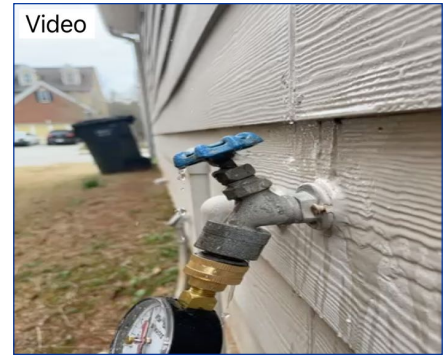
Hose Bib

Issue: The exterior hose bibs both leaked from the stem when tested.

Recommendation: Further evaluation by a qualified plumber to determine repair or replacement.

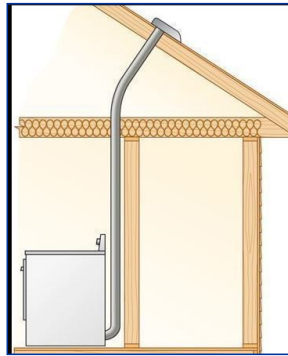
Dryer Vent

- The dryer vent was not accessible due to height restrictions on the roof.

Recommendations: It is recommended to have the dryer vent that exhaust to the roof cleaned yearly.

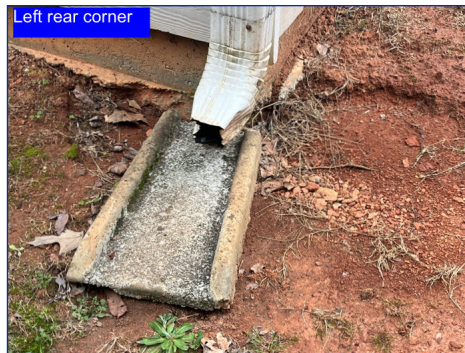
Foundation

•
Issue: The soil near the foundation of the back left corner is eroded. This is most likely caused by the downspout emptying next to the foundation.

Recommendation: Have the soil back filled around the foundation and the downspouts extended away from the home by a qualified landscape contractor.

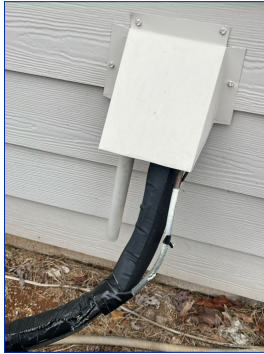
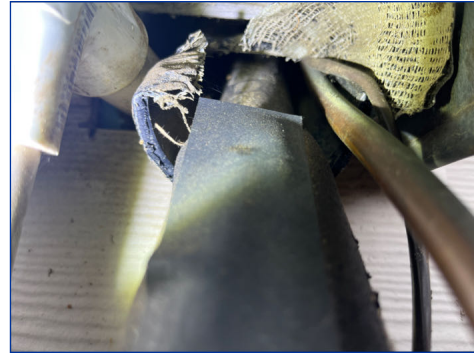
Condensate removal condition

- 1) The condensate line does not drain past the a/c pad.
- 2) There is an opening in the exterior wall where the HVAC lines run. This may allow pest to enter the home.

- 1) Extend the condensate drain line past the a/c pad to prevent any type of water buildup near the foundation.
- 2) Have all gaps properly sealed by a qualified contractor.

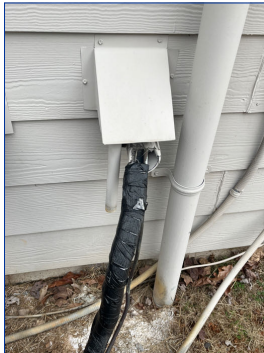
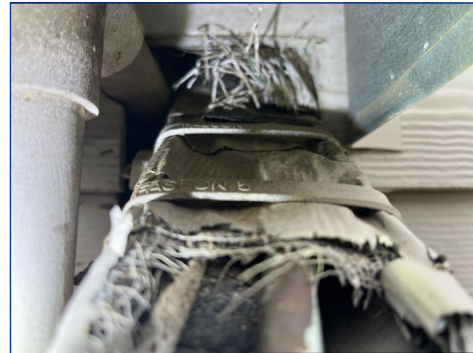
Condensate removal condition

- 1) The condensate line does not drain past the a/c pad.
- 2) There is an opening in the exterior wall where the HVAC lines run. This may allow pest to enter the home.

- 1) Extend the condensate drain line past the a/c pad to prevent any type of water buildup near the foundation.
- 2) Have all gaps properly sealed by a qualified contractor.

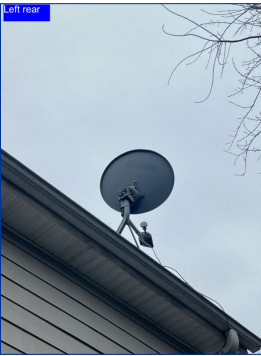
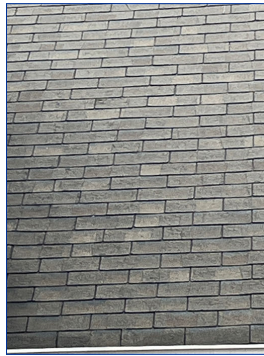
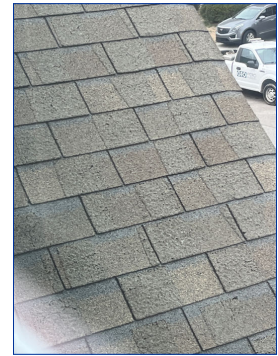
Roof covering condition

Issue: Some sections of the roofing shingles were not visible due to height restrictions and or safe access.

- 1) Roof shows signs of deterioration along the shingles.
- 2) A satellite dish is located on the back left corner. Over time the fasteners can pull away from the decking and allow water intrusion to the roof deck beneath the dish.

Recommendation: If other issues were noted for repairs have the roofer inspect these areas for proper installation and condition.

- 1) Monitor the roof for future deterioration,
 - 2) Have the dish removed and opening properly sealed by a qualified contractor
- Satellite

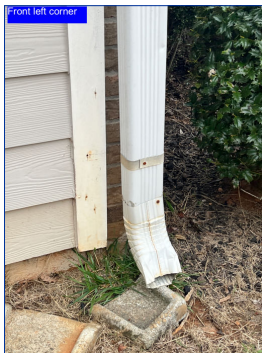
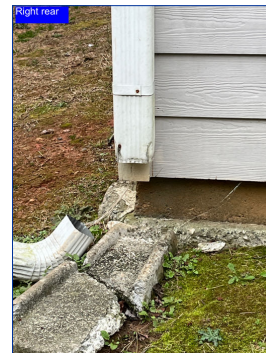
Downspout condition

- 1) The elbow section on the back right corner downspout is missing and depositing water at the foundation.
- 2) The front left downspout is not properly secured to the structure.

- 1) Have a new elbow installed and divert water away from the foundation wall.
- 2) Have the downspout secured to the structure by a qualified contractor.
