INTRODUCTION:

Inspection Details

Home Type: Single Family Home

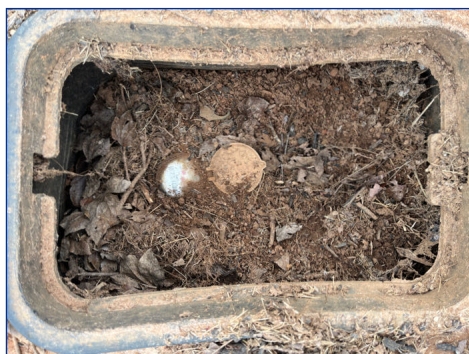
Water Meter

- Appears functional

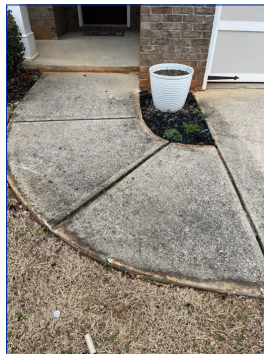
Walkway

- Appears functional

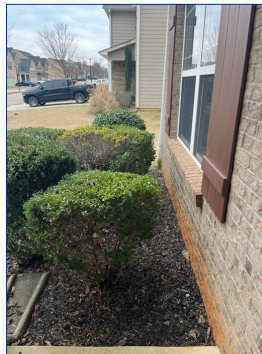
Vegetation

- Appears functional

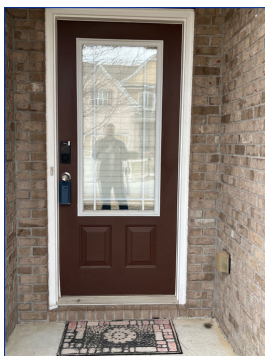
Front Door

- Appears functional

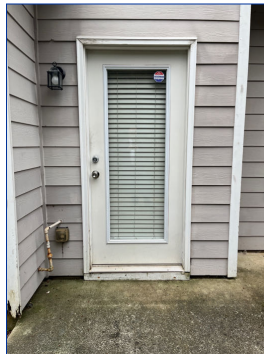
Rear door

- Appears functional

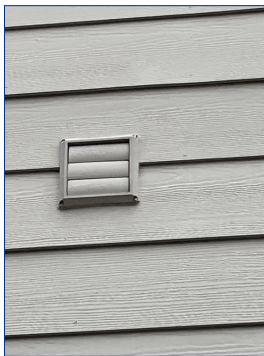
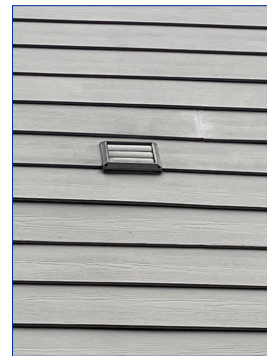
Bathroom Vent

- Appears functional

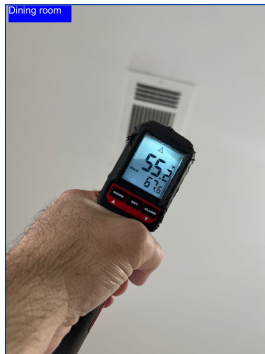
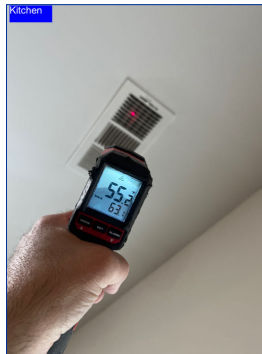
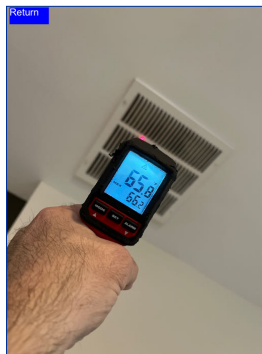
AC Issues

- Appears functional

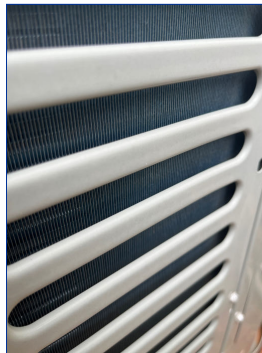
Coil Condition

- Appears functional

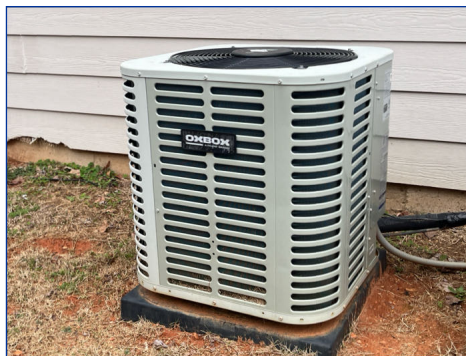
Exterior unit condition

- Appears functional

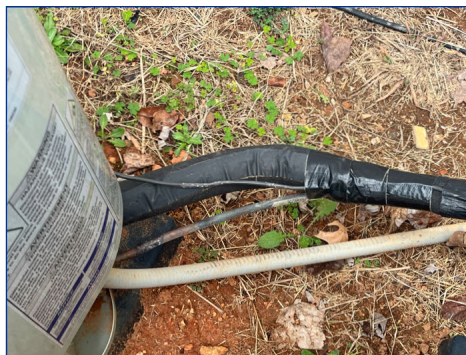
Refrigerant line condition

- Appears functional

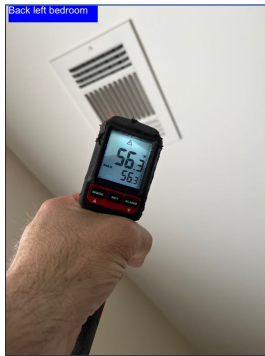
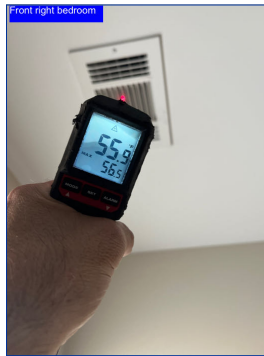
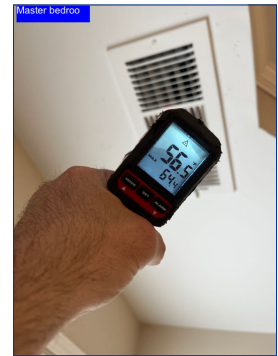
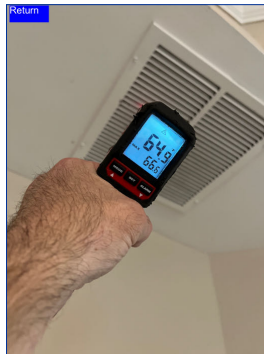
AC Issues

The Pictures/numbers are showing the temperature differentials between the supply and returns on the A/C system. This is one way for testing for proper operations.

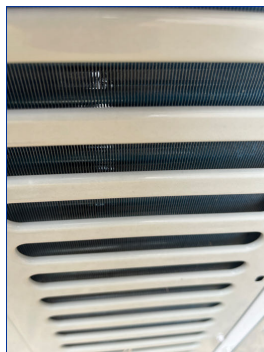
Coil Condition

- Appears functional

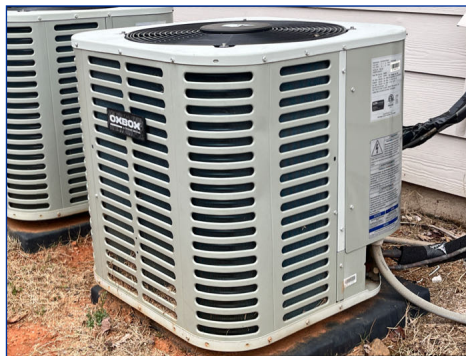
Exterior unit condition

- Appears functional

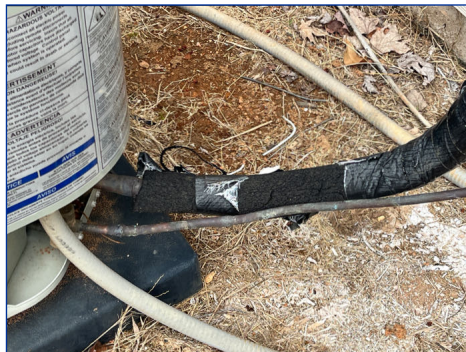
Refrigerant line condition

- Appears functional

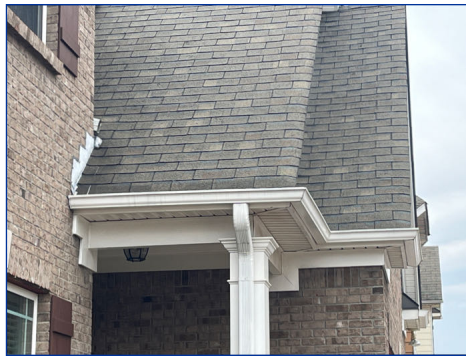
Gutter condition

- Appears functional
